An Investigation of the Therac-25 Accidents

Nancy Leveson, University of Washington

Clark S. Turner, University of California, Irvine

Reprinted with permission, *IEEE Computer*, Vol. 26, No. 7, July 1993, pp. 18-41.

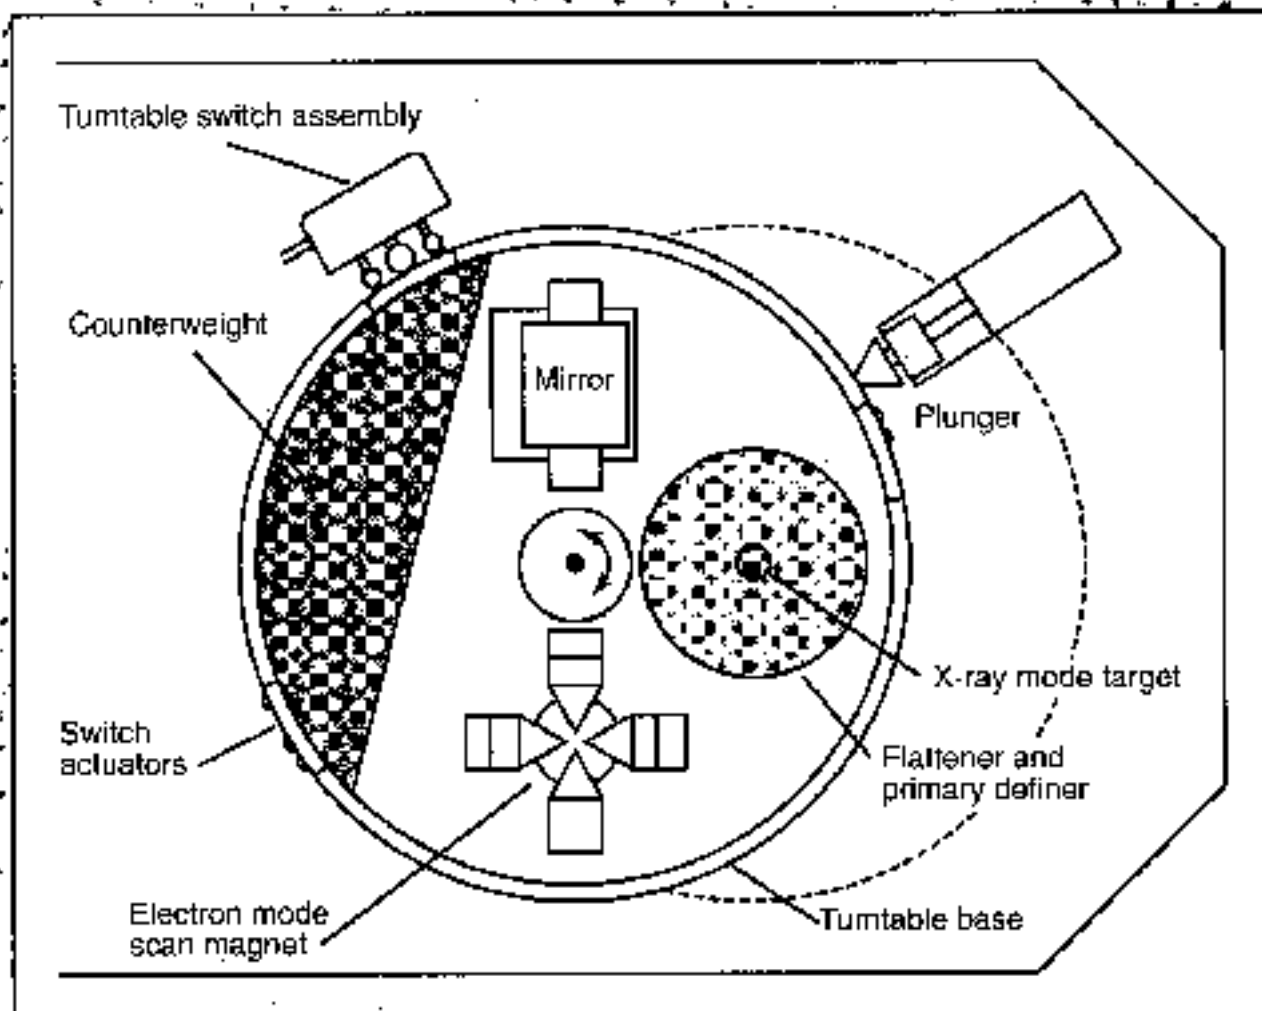
Figure B. 'Upper' turntable assembly.

No accelerator beam is expected in the field-light position. A stainless steel mirror is placed in the beam path and a light simulates the beam. This lets the operator see precisely where the beam will strike the patient and make necessary adjustments before treatment starts. There is no ion chamber in place at this turntable position, since no beam is expected.

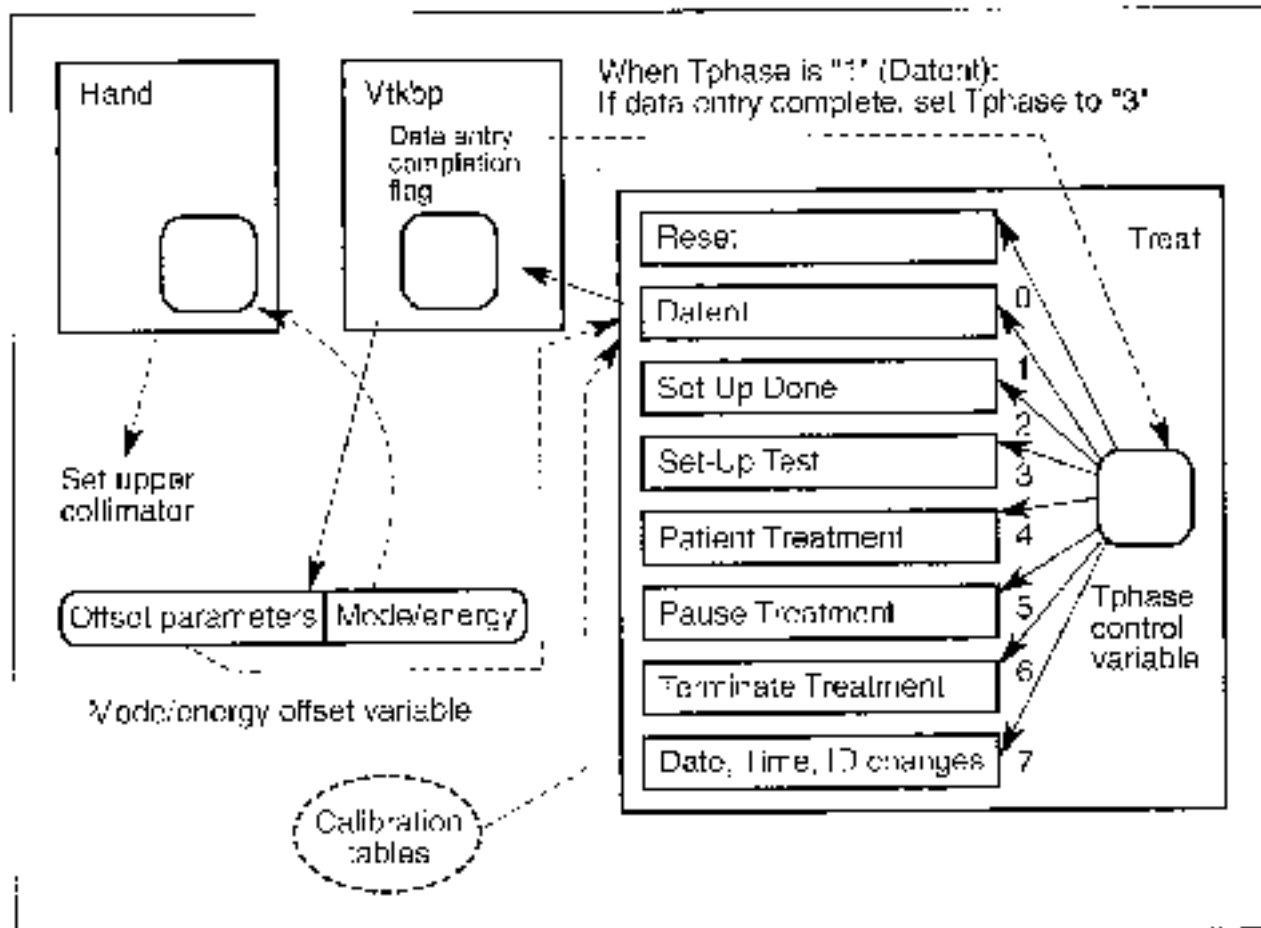
Figure 2. Tasks and subroutines in the code blamed for the Tyler accidents.

But this was not the only problem. Upon exit from the Magnet subroutine, the data-entry subroutine (Datent) checks the data-entry completion variable. If it indicates that data entry is complete, Datent sets Tphase to 3 and Datent is not entered again. If it is not set, Datent leaves Tphase unchanged, which means it will eventually be rescheduled. But the data-entry completion variable only indicates that the cursor has been down to the command line, not that it is still there. A potential race condition is set up. To fix this, AECL introduced another shared variable controlled by the keyboard handler task that indicates the cursor is not positioned on the command line. If this variable is set, then prescription entry is still in progress and the value of Tphase is left unchanged.

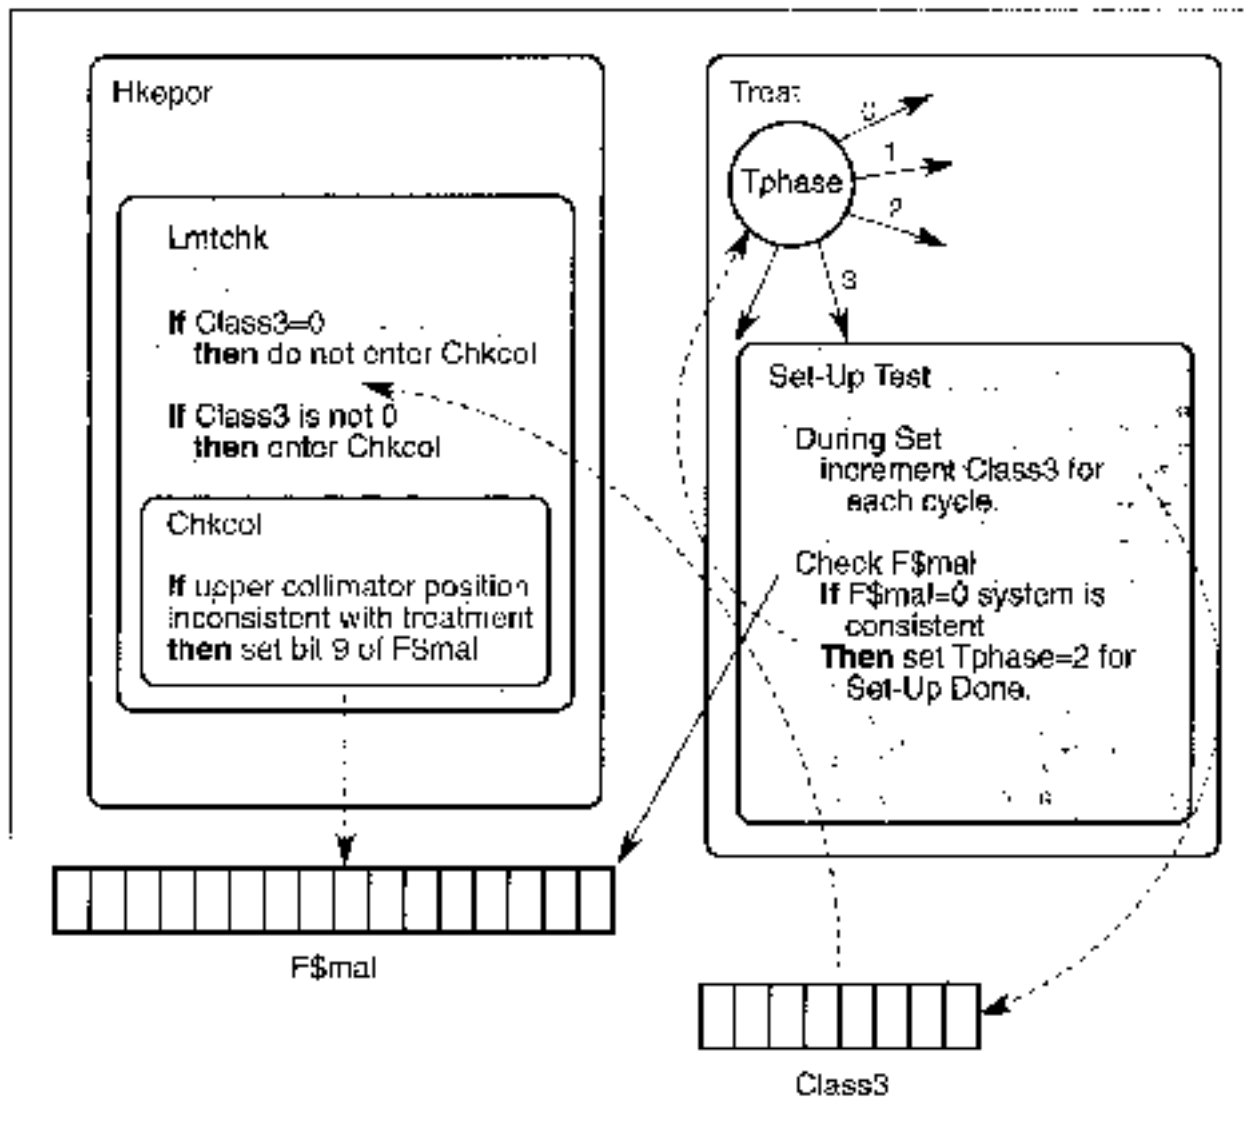
Figure 4. Yakima software flow.

The Yakima software problem. The software problem for the second Yakima accident is fairly well established and different from that implicated in the Tyler accidents. There is no way to determine what particular software design errors were related to the Kennestone, Hamilton, and first Yakima accidents. Given the unsafe programming practices exhibited in the code, it is possible that unknown race conditions or errors could have been responsible. There is speculation, however, that the Hamilton accident was the same as this second Yakima overdose. In a report of a conference call on January 26, 1987, between the AECL quality assurance manager and Ed Miller of the FDA discussing the Yakima accident, Miller notes

AECL described the technical "fix" implemented for this software flaw as simple: The program is changed so that the Class3 variable is set to some fixed nonzero value each time through Set-Up Test instead of being incremented.
